THE CHURCH OF ST JOHN THE BAPTIST, COLD OVERTON, LEICESTERSHIRE

BAT SURVEY AND ASSESSMENT IN RESPECT OF PROPOSED REPAIR WORKS AND BAT IMPACTS **FINAL**

Prepared for:
Cold Overton PCC

Report ref: P2017-28 R1 **FINAL**

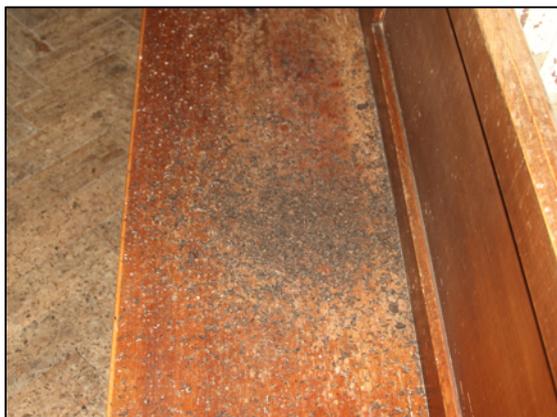
Figure 13 – Droppings on nave pews (at least 1 month since last cleaned)

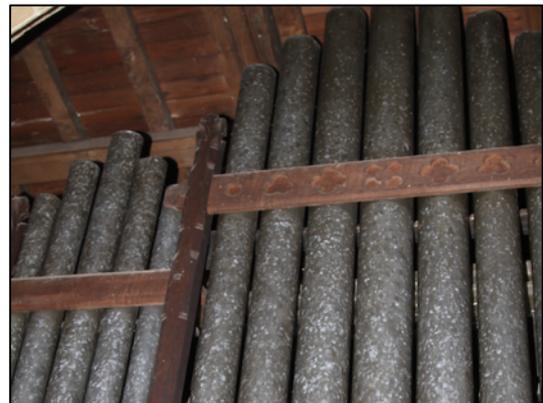
Figure 14 – Heavy urine staining on organ in north aisle

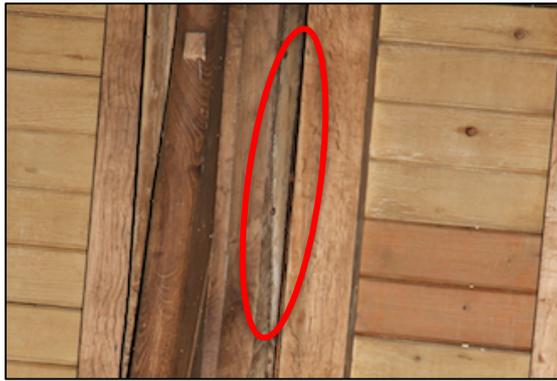
Figure 15 – Gap between principle nave rafter (2nd from the west) and timber boarding in the nave. This proved to be the main bat roosting area in the church

- 9.20 The soprano pipistrelles largely roost between the second principle from the west end of the church and the under boarding, where the rafter has pulled away leaving a suitable gap. There is also evidence that some bat roosting takes place under the rafter on the northern side and potentially between the western rafter and the end wall. Bats access the church either via the south-western or north-western corners of the nave.

- 9.22 Between the common rafter where the bats access, insert 15mm deep battens on the underside of the oak boards. These should be tight to the common rafters. Oak boards (to match the existing) should then be attached to the battens to create an enclosed box. This could be further sub-divided into chambers through the use of vertical battens. These boards would extend as far as the purlin giving a potential box size half the height of the roof.
- 9.23 The bottom boards should be removable to allow droppings to be cleared out if considered necessary.

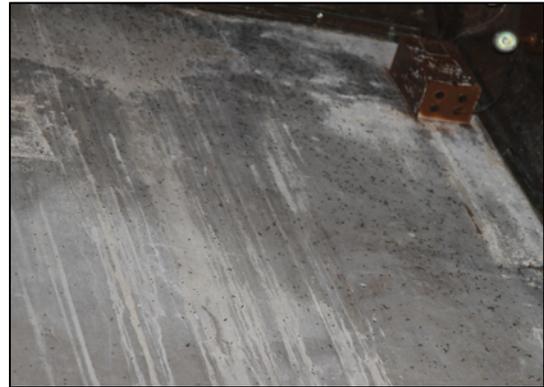
Figure 16 – South-west access point (nave) showing droppings on the wall

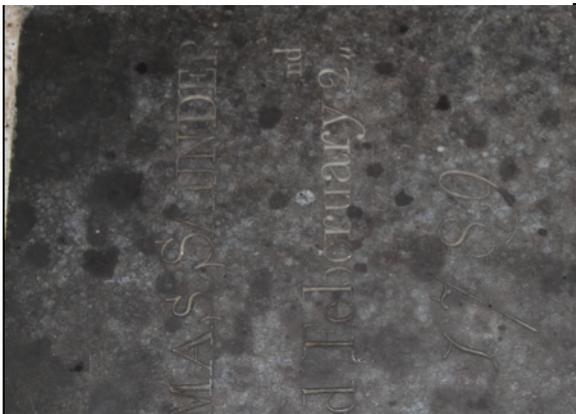
Figure 17 – Urine splashes on tombs (old = pale, fresh = dark)

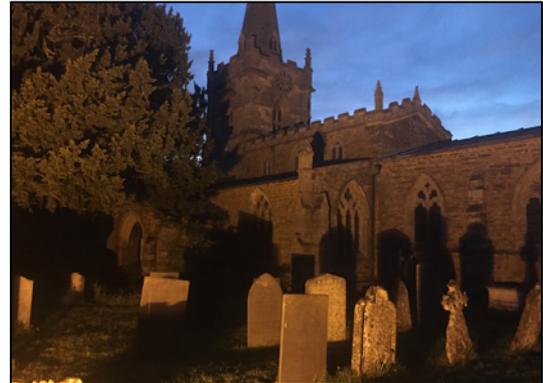
The surveys concentrated on the western end of the church as this was the area where most of the bat evidence was noted. Floodlights on the southern side of the church meant that any bat roosting and emergence on this elevation was considered most likely. During the re-entry survey, the northern elevation of the church (out of the floodlights) could be observed from the location of the observer and no bats were seen to enter. Very few bats have been recorded using the eastern end of the nave or the chancel internally when assessed on the internal cameras.

Figure 19 – The effect of floodlighting on church taken after bat emergence complete

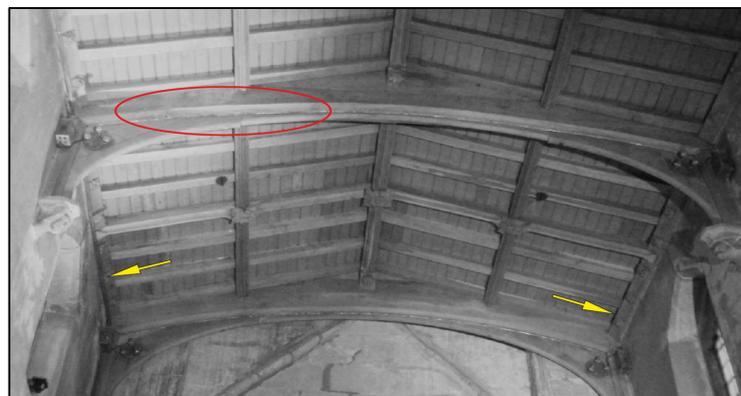
The survey has confirmed the presence of a moderate sized maternity roost of soprano pipistrelles (Peak count emerging from the church 144) – It assumed that the majority if not all of these would comprise adults as the young would still likely to remain in the roost/church in late June. Therefore, it can be assumed that the late summer colony size would probably be in excess of 200 (some soprano pipistrelle roosts can reach over 1000). In addition, there were small numbers of natterer's and individuals of common pipistrelles present. The emergence of the bats was much earlier than might normally be expected (i.e. about 15 minutes prior to sunset). It was thought to have been affected by the floodlighting (i.e. emerged before the lights came on).

Figure 20 – Location of bat access points and roosting area
